\$4.7 MILLION GENERAL DAMAGES VERDICT

ELECTROCUTION WRONGFUL DEATH

Estate of Pablo Padilla Ayala vs.
Southern California Edison Company
Holding a Public Utility Accountable
For High-Voltage Power Line Electrocution

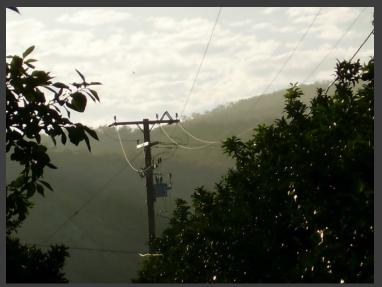
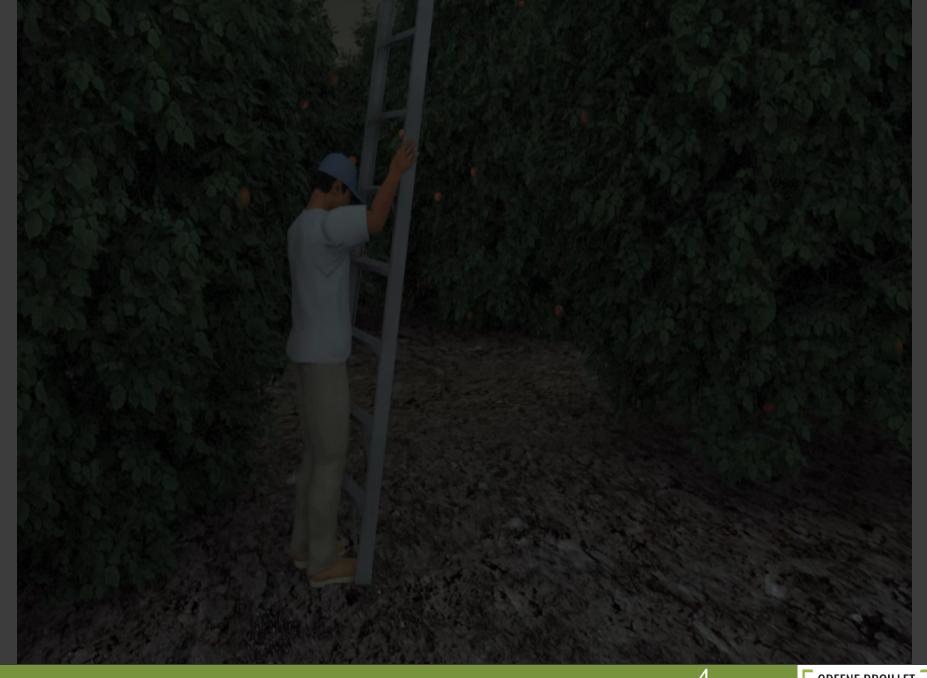
Pablo Padilla Electrocuted

- Experienced fruit harvestor
- Picking grapefruit from trees with a 20 foot ladder at 5:20 a.m.
- Three Power lines measured at 18'10", 21'5", & 22'4"
- Ladder contacted 12KV high voltage power transmission line.

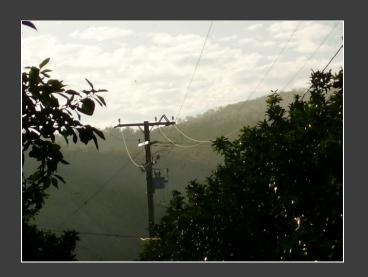
Exhibit 201-8

25 Foot Minimum Design to Remediate Hazard

SCE Measurements: 18'10", 21'5", & 22'4" (Tomas, TR 6/16/15, 99:3-8)

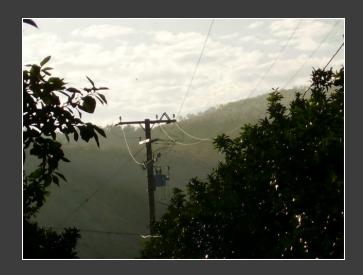
Exhibit 201-8

2009 Pole Replacement Never Inspected by SCE to Confirm 25 Feet Min Clearance for Safety

Actual Measurements: 18'10", 21'5", & 22'4" (Tomas, TR 6/16/15, 99:3-8)

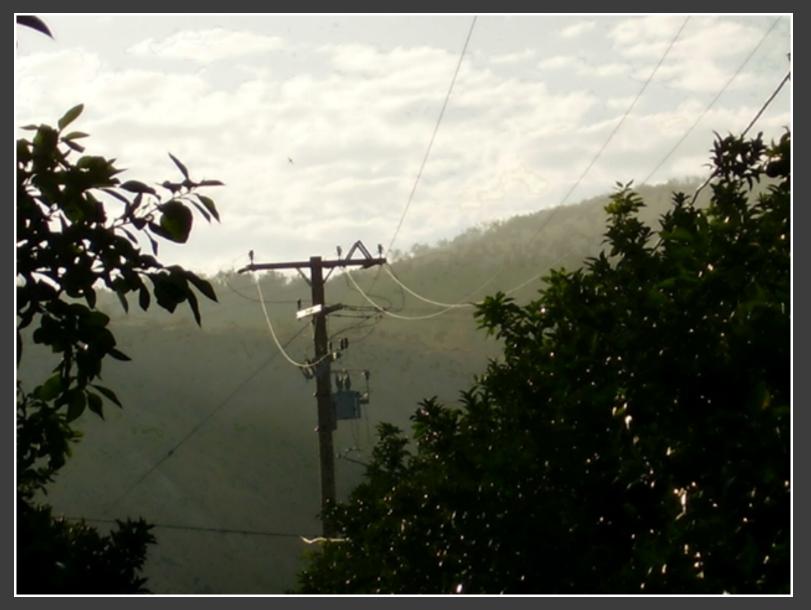
Exhibit 201-8 36

Three power lines had 3 ½ foot variation in height: 18'10", 21'5", & 22'4".
